Keith A. Jagers November 1978

Updates – November 2011

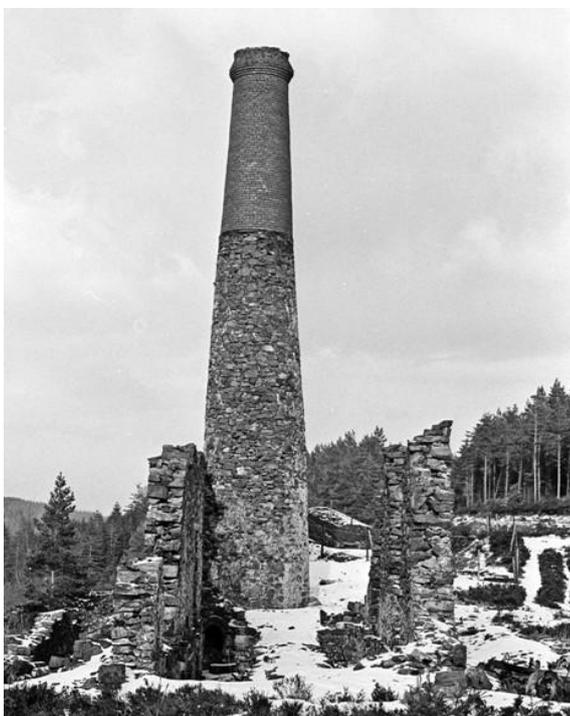
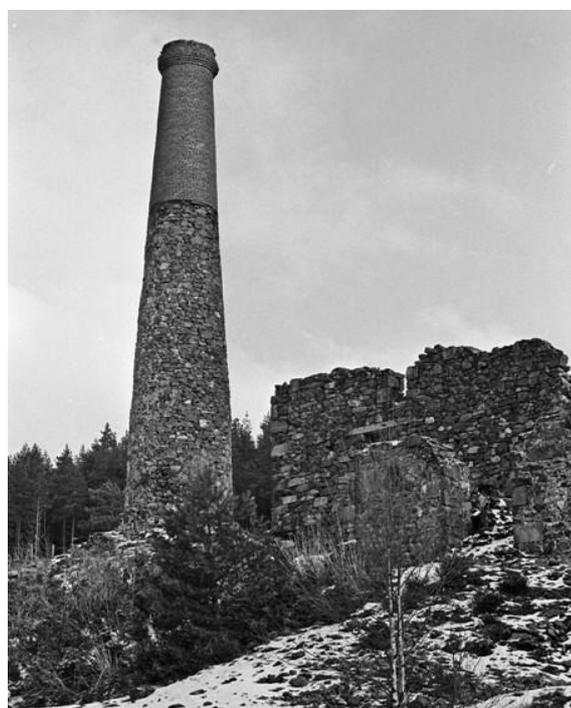
Parc Mine (788603) was one of the largest, most productive and most recent worked of the North Wales lead mines, as a sight of the vast ugly slurry tips alongside the road will testify. It was closed first in 1905, re-opened in 1919 and closed again, before a final reworking occurred in 1952-3 as the Llanrwst Lead Mines Co. Ltd. After 1963 the crushing mill was used by the Pengwern and Gwydyr Granite Co. for crushing granite obtained elsewhere, until 1967 when the surplus machinery was sold. The former workings also have recently been used for experiments in connection with automatic ore treatment processes.

As would be expected therefore, although there is evidence of a complex array of buildings, levels and tipping areas, most of what is to be seen is from the era of steel, concrete and corrugated iron - the first and last largely now vanished in the hands of scrap dealers. The Forestry Commission road climbing up past the crushing mill was formerly the main tramway incline, near the top of which, some 150 yards above the mill, is an entrance to further workings which may be entered for distances of up to half a mile or so - inside the tunnels, the 2 ft gauge tramway track and points survive. These tunnels have recently been used by university experimenters requiring a constant temperature, stable environment.

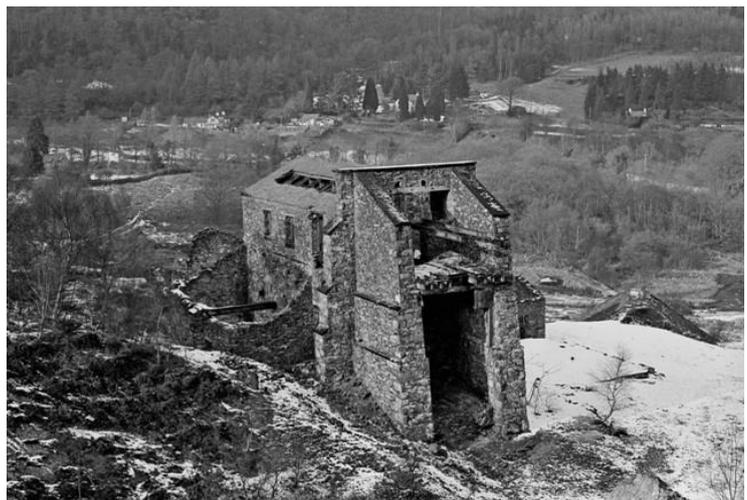
From here, an aerial ropeway carried the ore to another large mill, which survives in good condition in the valley below. This is Klondyke Mill (picture right), no doubt so named to suitably inspire the would-be investor, which also

served the nearby Klondyke Mine. The entrance to these workings, dating from 1919, may be seen on the riverbank opposite, and may be entered with care. A more direct approach to the mill is via the Crafnant Valley road, from which the building is a prominent landmark (762624); one can park and take the path through the campsite and across the footbridge. The mill was latterly powered by an 82 hp turbine, using water from Llyn Geirionydd.

The former tramway route from Geirionydd Mine, along the lakeside towards **Klondyke Mill** is now a good single-track road, and the old trackbed diverges from this off to the left just beyond the north end of the lake. The main Klondyke crushing mill survives, though not nowadays quite so dominant as seen from the Crafnant Valley road, due to intervening vegetation growth.
